Focused Improvement Project: Downtime Reduction – Mechanical Joining Technology

Mveleli Mbombo

May 2019

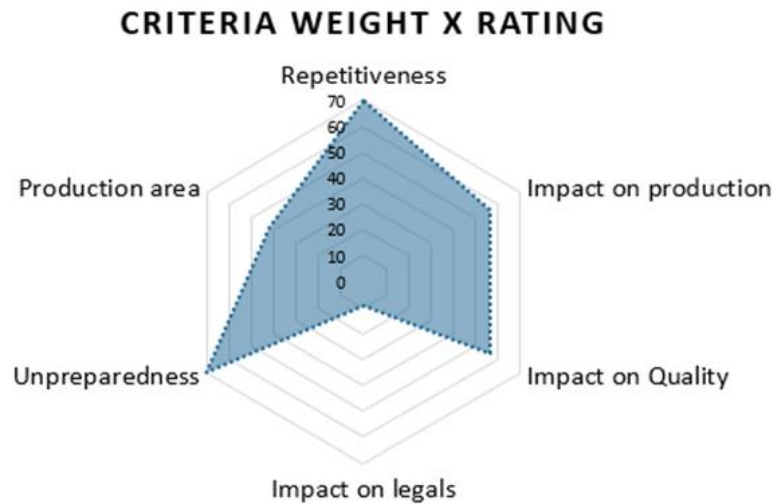
Project Prioritisation Matrix

Problem prioritisation matrix designed by the asset management team and used to quantify and rank issues to determine the required appropriate actions

- The hit map shows the results from the project analysis and prioritisation
- High scoring aspects are unpreparedness and repetitiveness

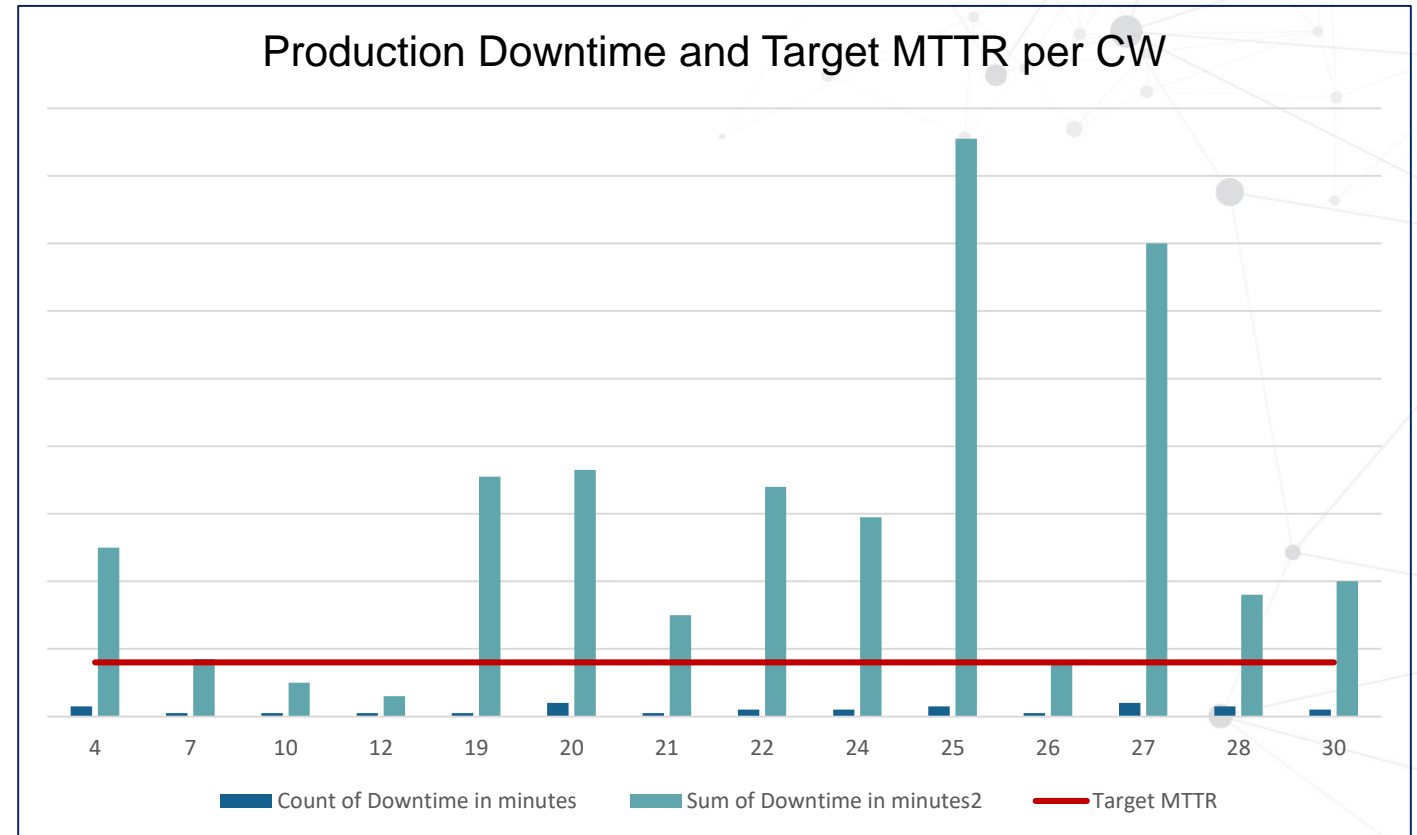
Total production downtime lost year to date at the station

85% of the faults from left hand side of the station

66% of the faults reported as unscrewing faults from the mandrel

Inaccurate information gathered about the problem. HMI and PLC not synchronised, HMI identified actual faults which were reported as unscrewing faults by the PLC

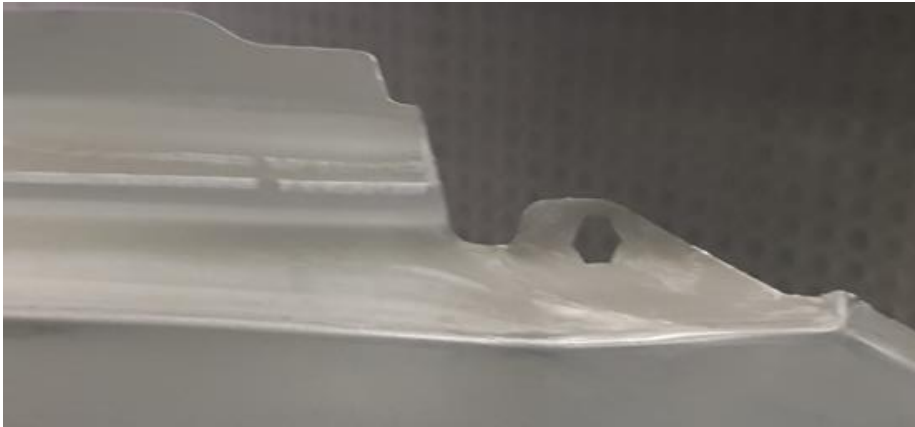
Left Side wall

The logistics/parts specialist had measured the diameter of the hexagonal part-hole and found it to be within the specified tolerance

Picture on the right depicts a part that has an angle slightly twisted but was later proven to be an isolated incident by the logistics specialist

Handling of the part – most experienced operator were put at the station and production team manager monitored to ensure that the handling does not cause damage to the part angle

This eliminates the part from possible causes

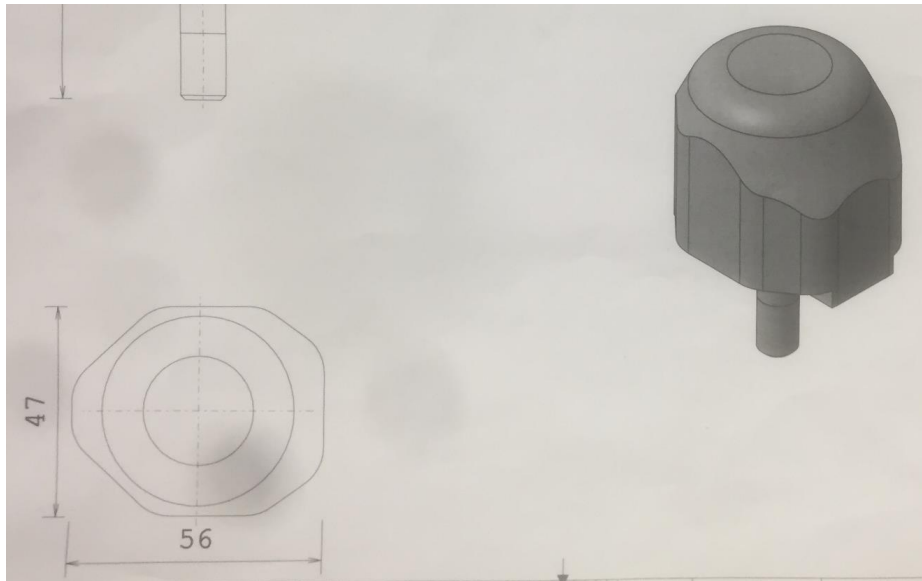
Original locating pin dimensions

When comparing the two diagrams original locating pin and current pin size, one notes that the locating pins are still within the 0.5 mm tolerance

This eliminates the locating pin from possible causes

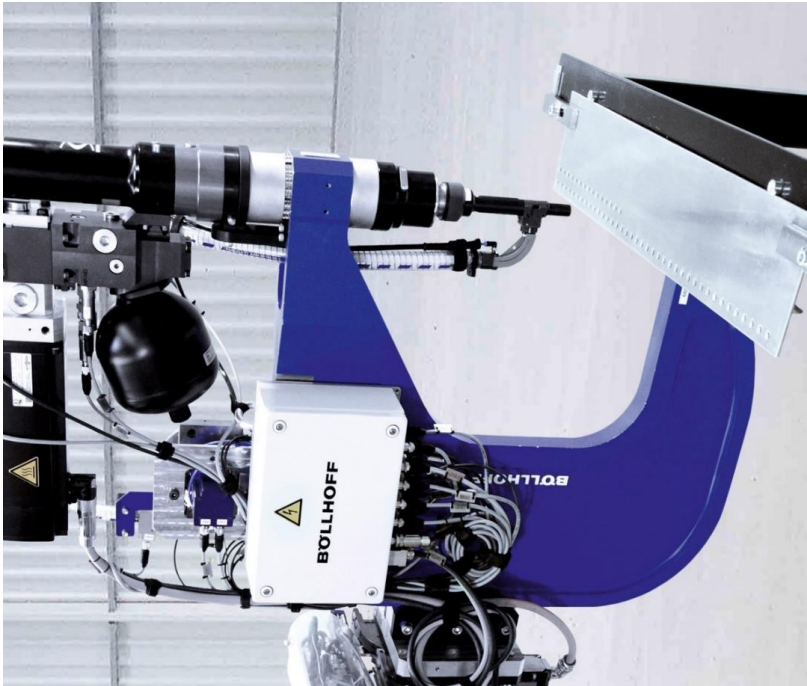
Riveting gun (Source: Boellhoff.com)

The mechanical joining specialist has tested the gun on numerous occasions and proved that the gun is shooting accurately

In the previous calendar weeks the specialist has replaced the gun with a new gun from the store and has high confidence that the gun is shooting accurately

All necessary steps have been taken in ensuring that the gun is operating with no faults. Compensation rubber changed and mandrel replaced more frequently by the artisans

This eliminates the gun from possible causes

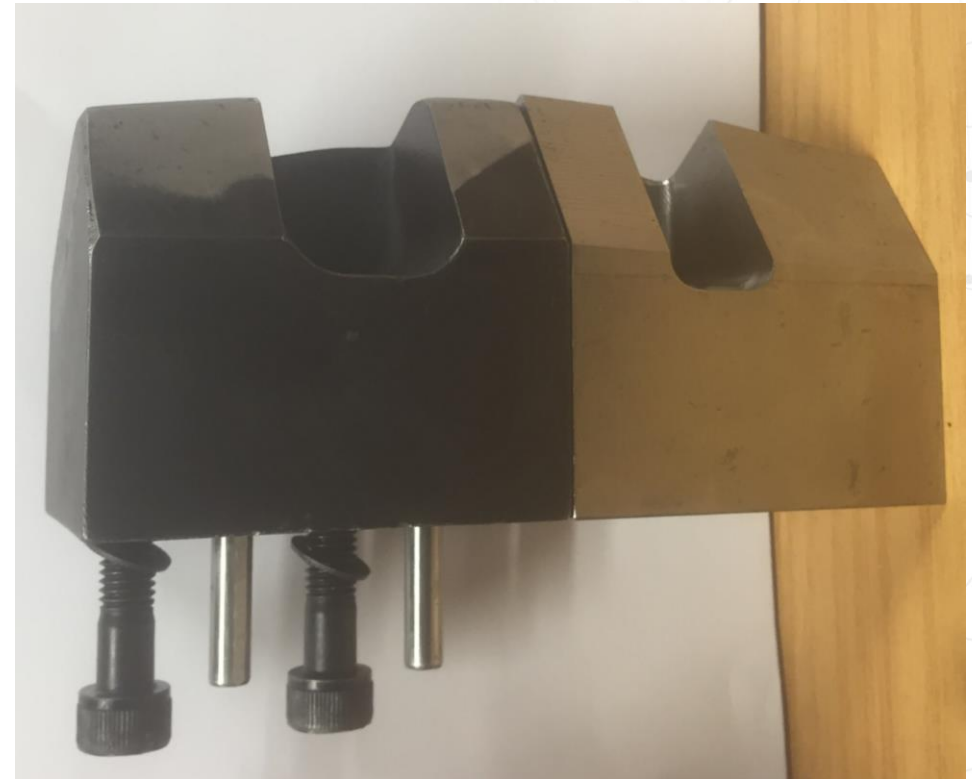
New clamp mylar and old clamp mylar

- The entire team decided to hold meetings at the station while operating and see what else could cause the gun and part-hole misalignment
- On calendar week 37, the team agreed to replace the mylar with a newly manufactured mylar
- The new clamp mylar has a larger surface area and hinges against the corner of the side wall. This minimises the allowable part movement on both X and Y axes and provides extra stability to the part

- ❑ Activate weekly PM for replacement of mandrel to prevent failures due to a worn mandrel
- ❑ Introduced an annual PM for replacement of the compensation rubber
- ❑ Draw up a new SPL documenting all the processes followed to ensure that the problem is solved efficiently in future
- ❑ Manufacture same sized mylars for all similar riveting stations

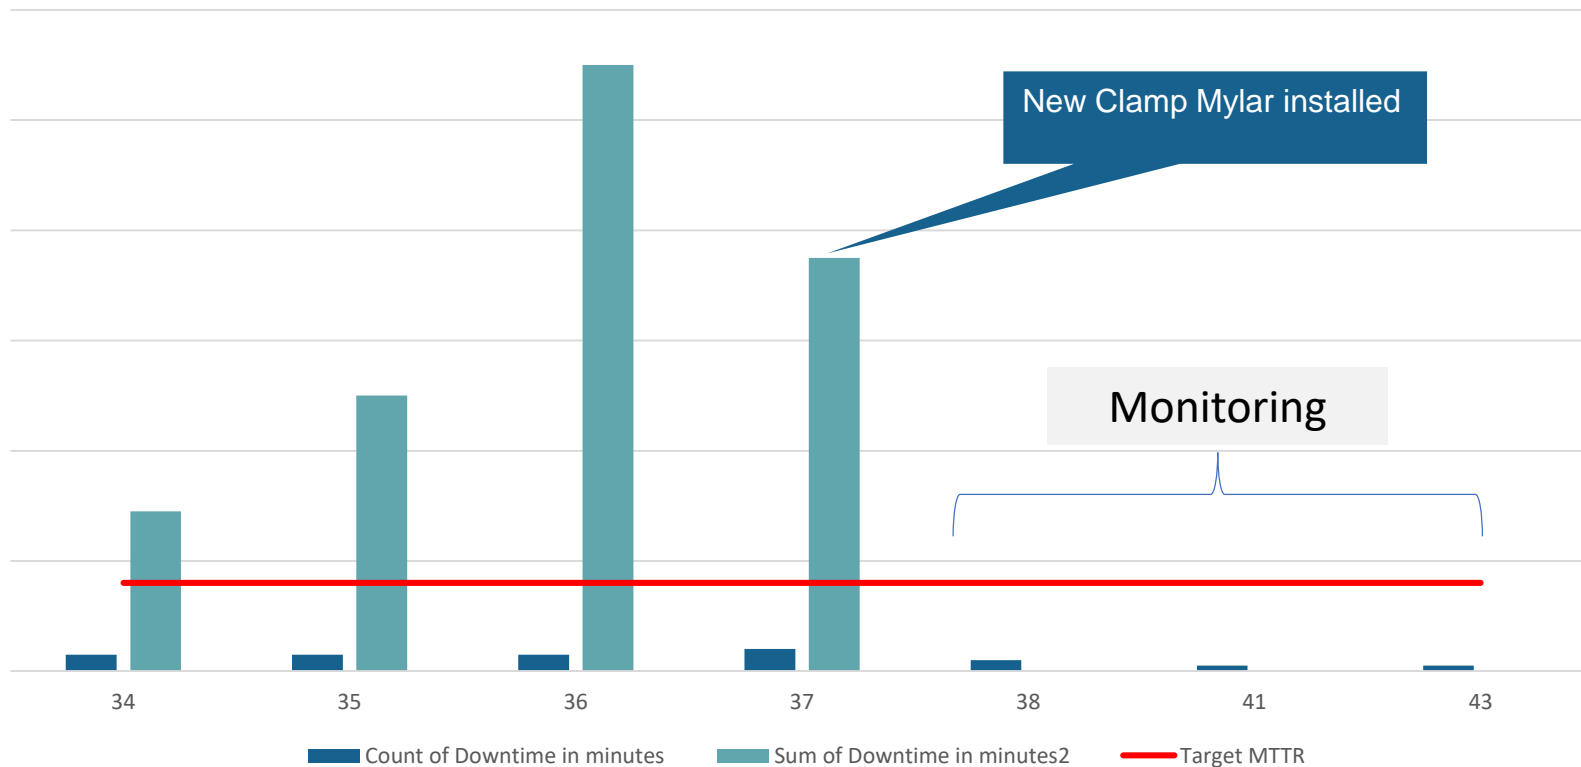
Production Downtime and Target MTRR per CW

- The combination of the improvement actions undertaken resulted in zero production downtime in calendar week 38.
- The team agreed to monitor the station for the next three weeks.

The station was monitored from calendar week 37 to 40 and there were no production downtime recorded. Control measures put in place to cement the improvement achieved and FMEA sheet has been updated as follows
